Sustainability Assessment Usage, Technology and Functionality of Toilets in Rural Bihar (July-November 2019)

SUSTAINING ODF OUTCOMES

FINISH Society

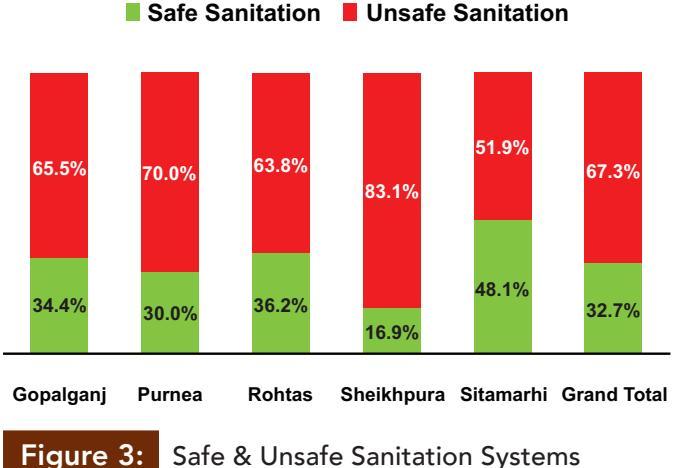
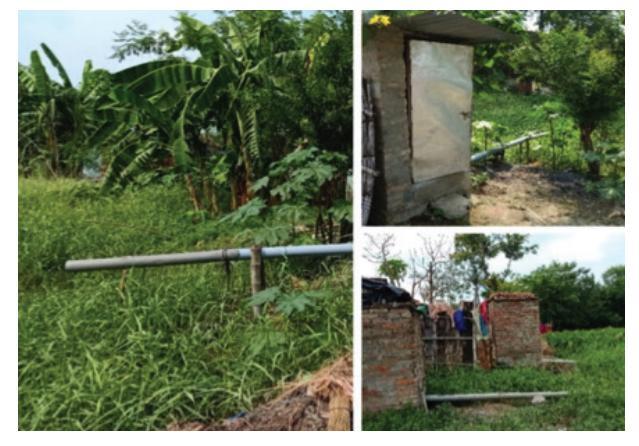
Overall 69 percent toilets were found to be unsafe or unimproved toilets.30 percent of the toilets were found to be single leach pits without a junction chamber, 27 percent of the toilets were found to be septic tanks without a soak pit and 9 percent toilets were twin leach pits without junction chamber.

Design and construction of toilets not only directly affects the containment and treatment of faecal matter and thereby, the environment, but also affects the unit's durability, comfort and accessibility which affects usage. For overall assessment of environmental safety and sustainability in this study, septic tank toilets with soak pit, twin pits with JC and single pits with JC are being grouped as **improved or safe sanitation systems** whereas septic tanks without soak pit, single pits without JC, twin pits without JC, toilets discharging into open drains and Shankar toilets are being grouped as **unimproved or unsafe sanitation systems**.

Photo: Toilets with outlet in the open Safe & Unsafe Sanitation Systems

We stand in need for retrofitting solutions to convert single-pits into double-pit toilets, converting holding or containment tanks into proper septic tanks to ensure sustainable management of faeces. However, identifying unsafe toilets, sensitizing users to convert existing unsafe toilets into safe toilets and more importantly, finding money to enable this, are going to be key challenges going forward.

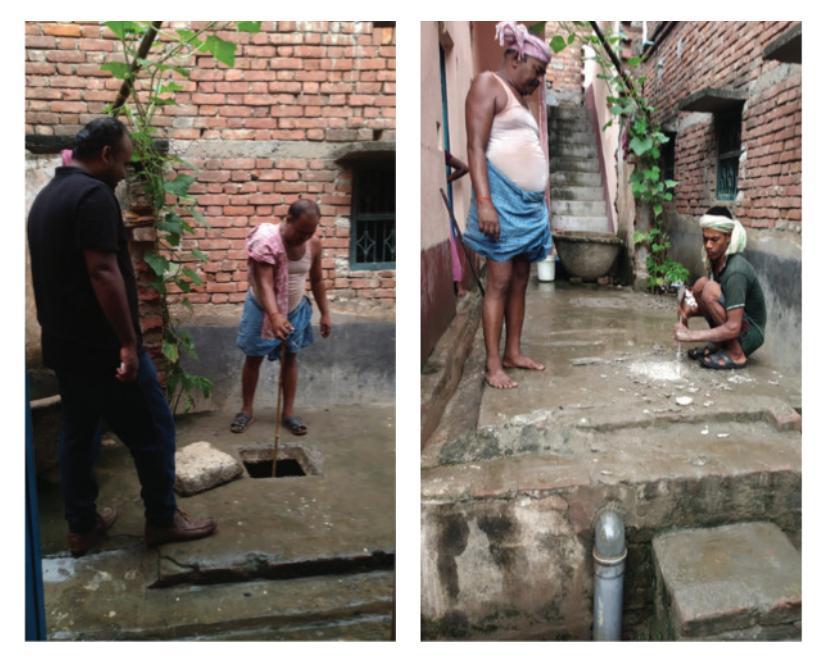
Depths of pits/tanks and volume of the sub structure (below the ground) are critical parts of a safe or sanitary toilet. The greater the depth, the greater the cost of excavation, lining and cleaning, along with the potential to contaminate the ground water. The study finds that 44 percent of the total leach pits are 1.8-3 meters deep, while only 3 percent of the pits were near the prescribed range of 1 meter. This was also confirmed by the results of the technical audit done for selected toilets. Only 10 percent of the septic tanks covered in the technical audit had two or more chambers. Except for Purnea, in all other districts, there are more cases where the distance between the pits and the water source is less than 10 meters. 27 percent of toilets were found to be septic tanks without soak pits with outlet into an open drain or built as sealed tanks. This clearly presents a threat to ground water contamination. Therefore, it is highly recommended that water quality tests should be carried out to understand whether the water possesses a health risk for some households/ communities.

Photo: Assessment of sub-structure as part of the technical audit.

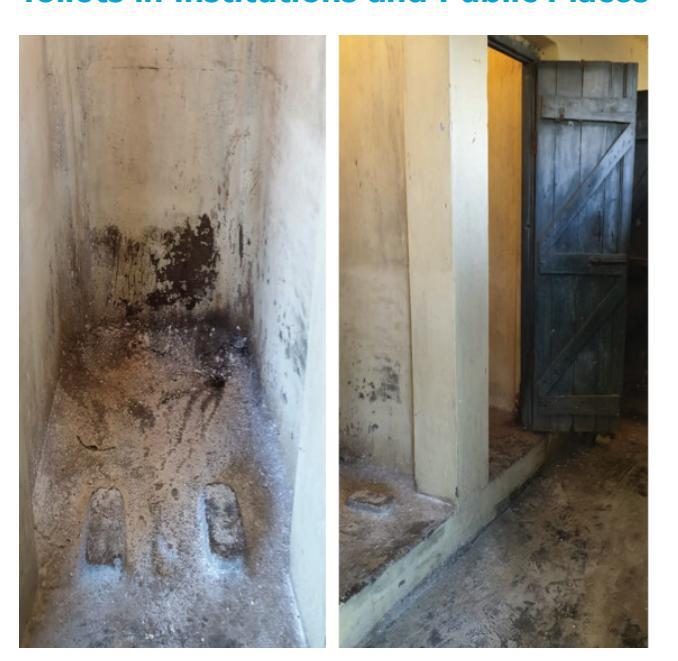
Photo: Unsanitary condition of toilets in Manjhagarh Railway Station

- While availability of toilets itself seem to be a challenge, adequacy with respect to people visiting bus stands, railway stations and hotels on highways, are of concern too. Most of the toilet types are septic tanks without soak pits and safe emptying of waste could be a challenge in the future upon filling.

- Water availability was not observed to be a challenge but hand washing stations enabling access of hand washing after use of toilets was not available. Toilets visited were in use and fully operational but had poor quality and maintenance. Out of all surveyed toilets, disabled-friendly units were only found in petrol pumps (2 nos).

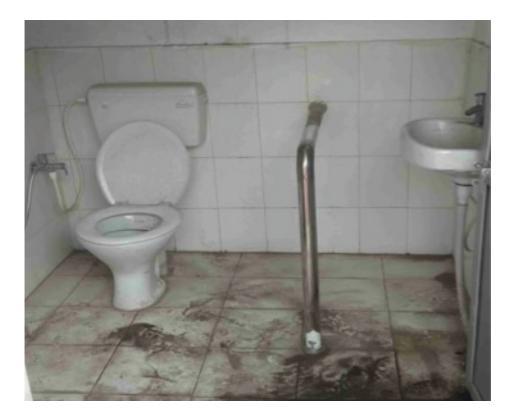
Photo: Ergonomic toilet seen in a petrol pump

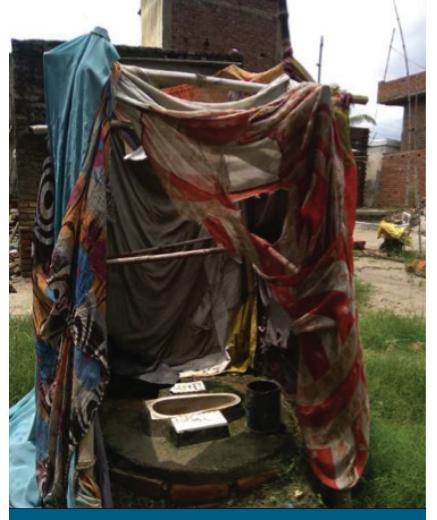
Toilet with an unsatisfactory superstructure and without a door.

While the need for toilet cleaning has come out as the largest component for improvement in toilets, the need for repair of necessary infrastructure (e.g. doors, roofs) are also significant. These observations do not include the technical gaps and their retrofitting requirements. Challenges in accessing an existing toilet and their quality have direct implications on its functionality and in turn, the usage.

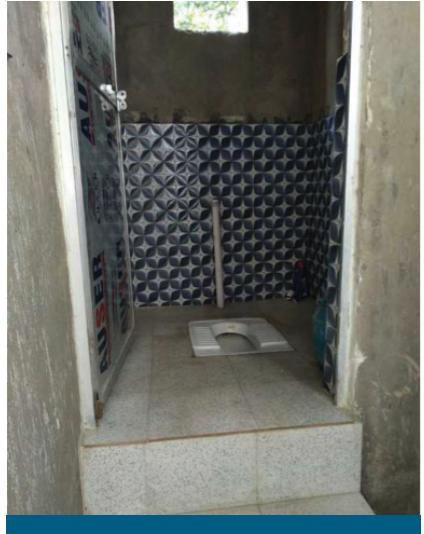
Hygienic and a well-ventilated toilet.

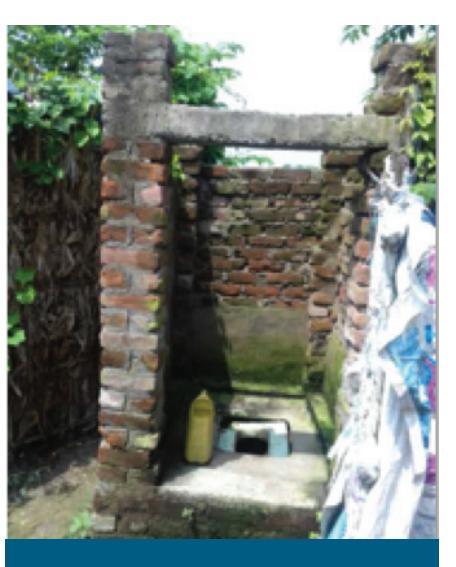
Toilet without a door and roof.

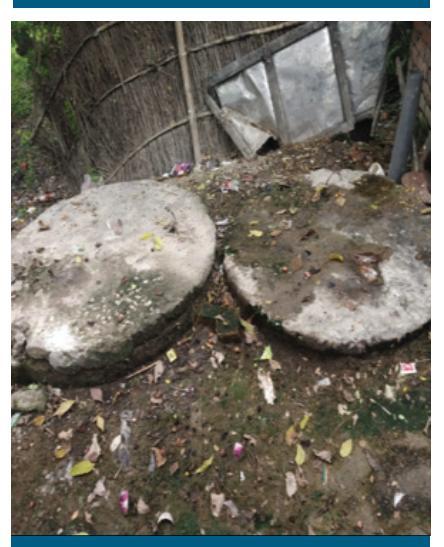
In the case of leach pit toilets, common challenges found are presence of single pits, very deep pits, distance between the pits and nearby water source, pits not lined properly, absence of junction chamber, etc. While in the case of septic tanks, most of the toilets found are more like holding tanks with outlet connected to drainage. Size of the pits and tanks are also largely primarily linked to the anxiety around pit/tank filling. Defective engineering designs and sub-standard quality face the risk of contaminating the ground water and being abandoned in future.

Distance between the two leach pits is less than 1 meter.

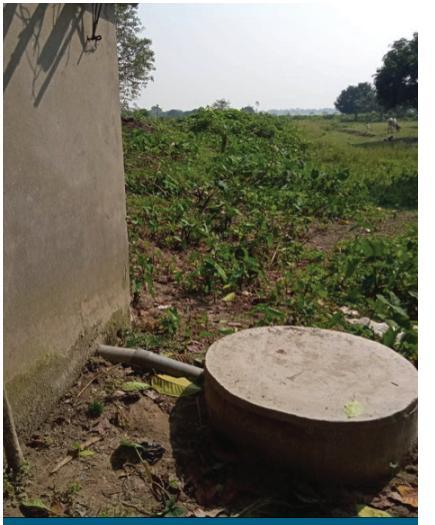
Toilet linked to a single leach pit.

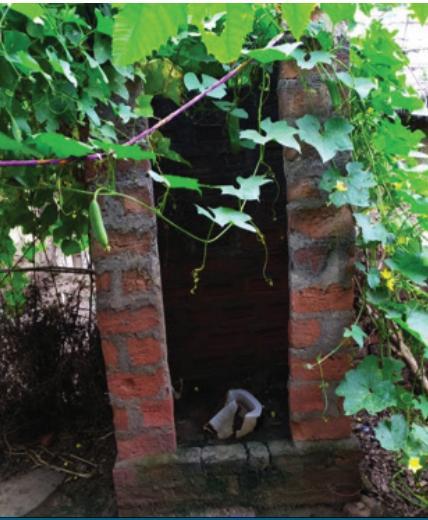
A broken toilet pan with substandard super structure.
